T&R UPDATE THE REAL DIRT ON REFLECTIVE ROOFS

Single-Ply Membranes and Reflectivity Reality

by Mathew Dupuis, PhD, PE

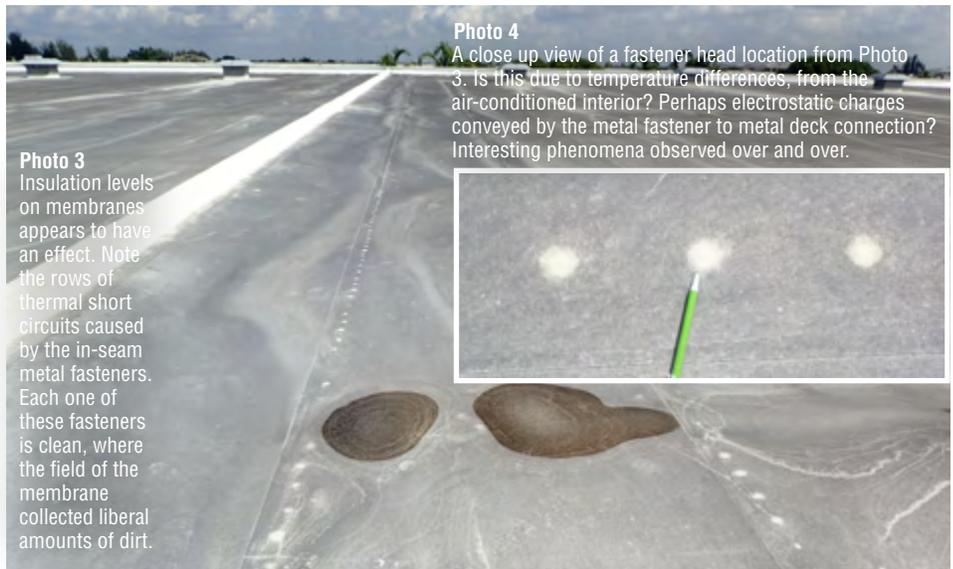
Photo 3 Insulation levels on membranes appears to have an effect. Note the rows of thermal short circuits caused by the in-seam metal fasteners. Each one of these fasteners is clean, where the field of the membrane collected liberal amounts of dirt.

Photo 4 A close up view of a fastener head location from Photo 3. Is this due to temperature differences, from the air-conditioned interior? Perhaps electrostatic charges conveyed by the metal fastener to metal deck connection? Interesting phenomena observed over and over.

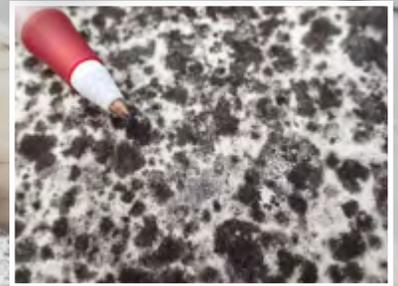
Photo 2 Biological growth (mildew) on the surface of Single-ply membranes in hot humid southern climates, markedly decreases solar reflectivity.

Photo 1 Biological growth has impeded full drainage. Reflectivity typically suffers in these areas

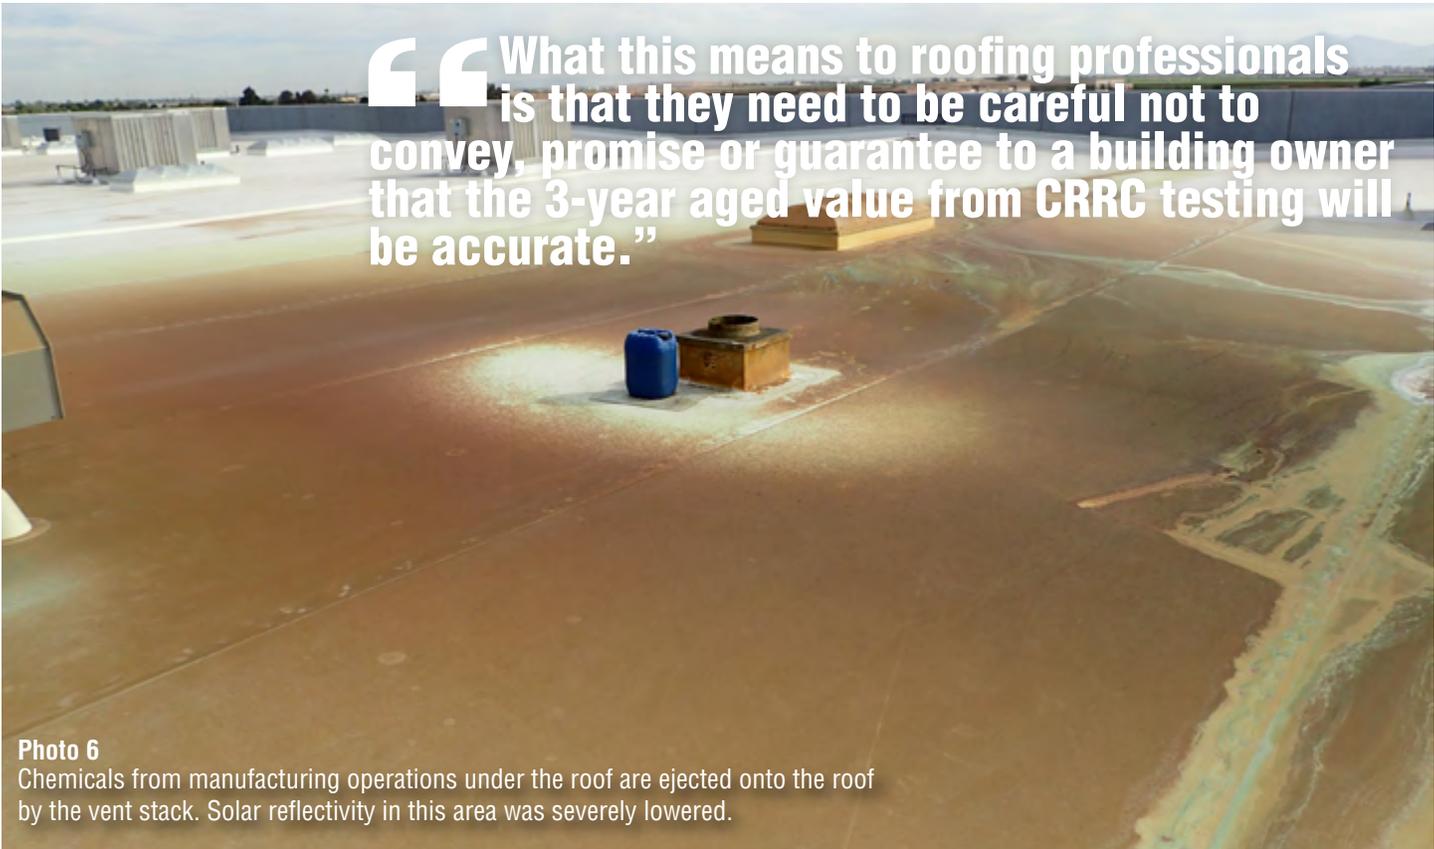
Photo 6

Chemicals from manufacturing operations under the roof are ejected onto the roof by the vent stack. Solar reflectivity in this area was severely lowered.

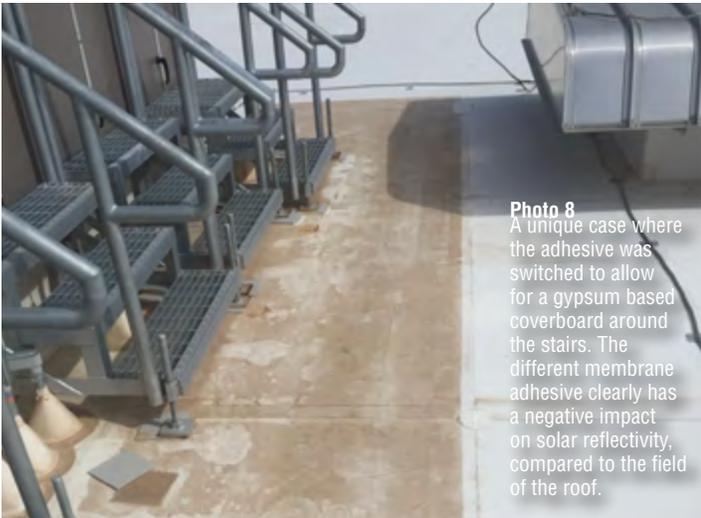
Photo 8
A unique case where the adhesive was switched to allow for a gypsum based coverboard around the stairs. The different membrane adhesive clearly has a negative impact on solar reflectivity, compared to the field of the roof.

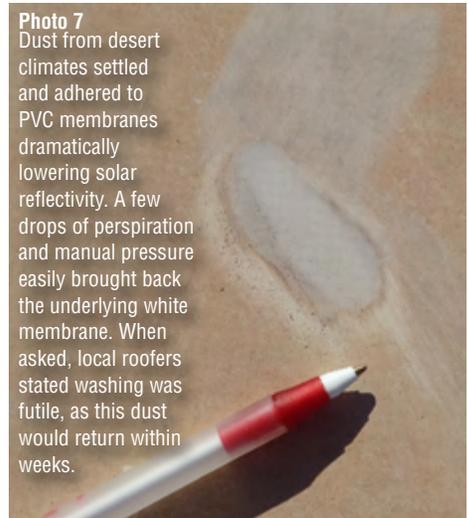
Photo 7
Dust from desert climates settled and adhered to PVC membranes dramatically lowering solar reflectivity. A few drops of perspiration and manual pressure easily brought back the underlying white membrane. When asked, local roofers stated washing was futile, as this dust would return within weeks.
